REPORT NUMBER 301L-GTL-04-002

# SAFETY COMPLIANCE TESTING FOR FMVSS NO. 301L FUEL SYSTEM INTEGRITY

GENERAL MOTORS CORP.  
2004 CHEVROLET EXPRESS, MPV  
NHTSA NO. C40111

GENERAL TESTING LABORATORIES, INC.  
1623 LEEDSTOWN ROAD  
COLONIAL BEACH, VIRGINIA 22443

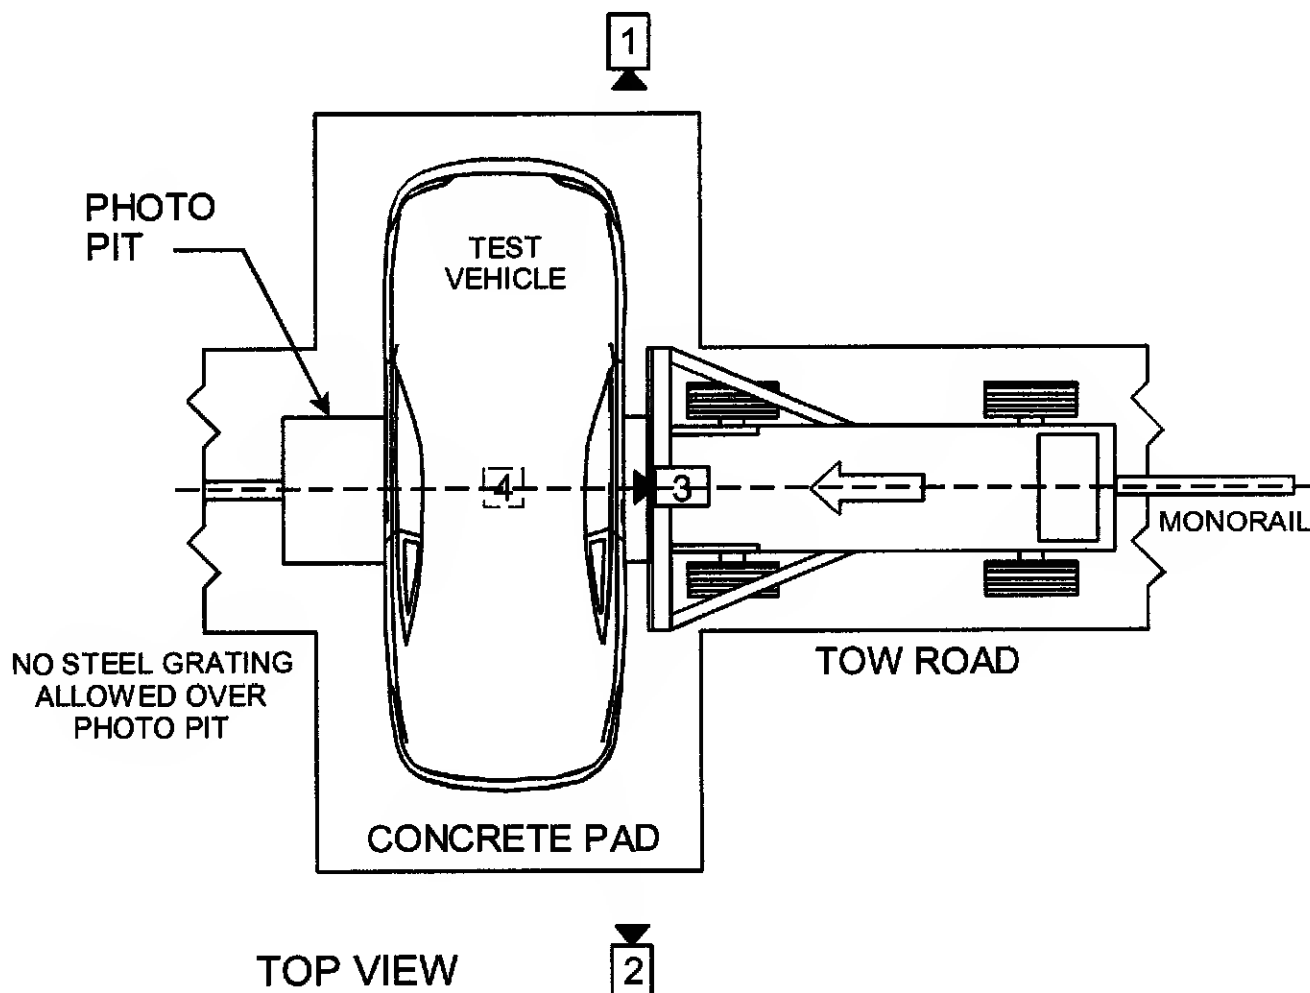
# DATA SHEET 6 CAMERA LOCATION

- CAMERA 1 – REAR SIDE VIEW OF VEHICLE DURING CRASH
- CAMERA 2 – FRONT SIDE VIEW OF VEHICLE DURING CRASH
- CAMERA 3 – OVERHEAD VIEW OF ENTIRE IMPACT
- CAMERA 4 – UNDERBODY VIEW OF FUEL TANK LOCATED IN PIT

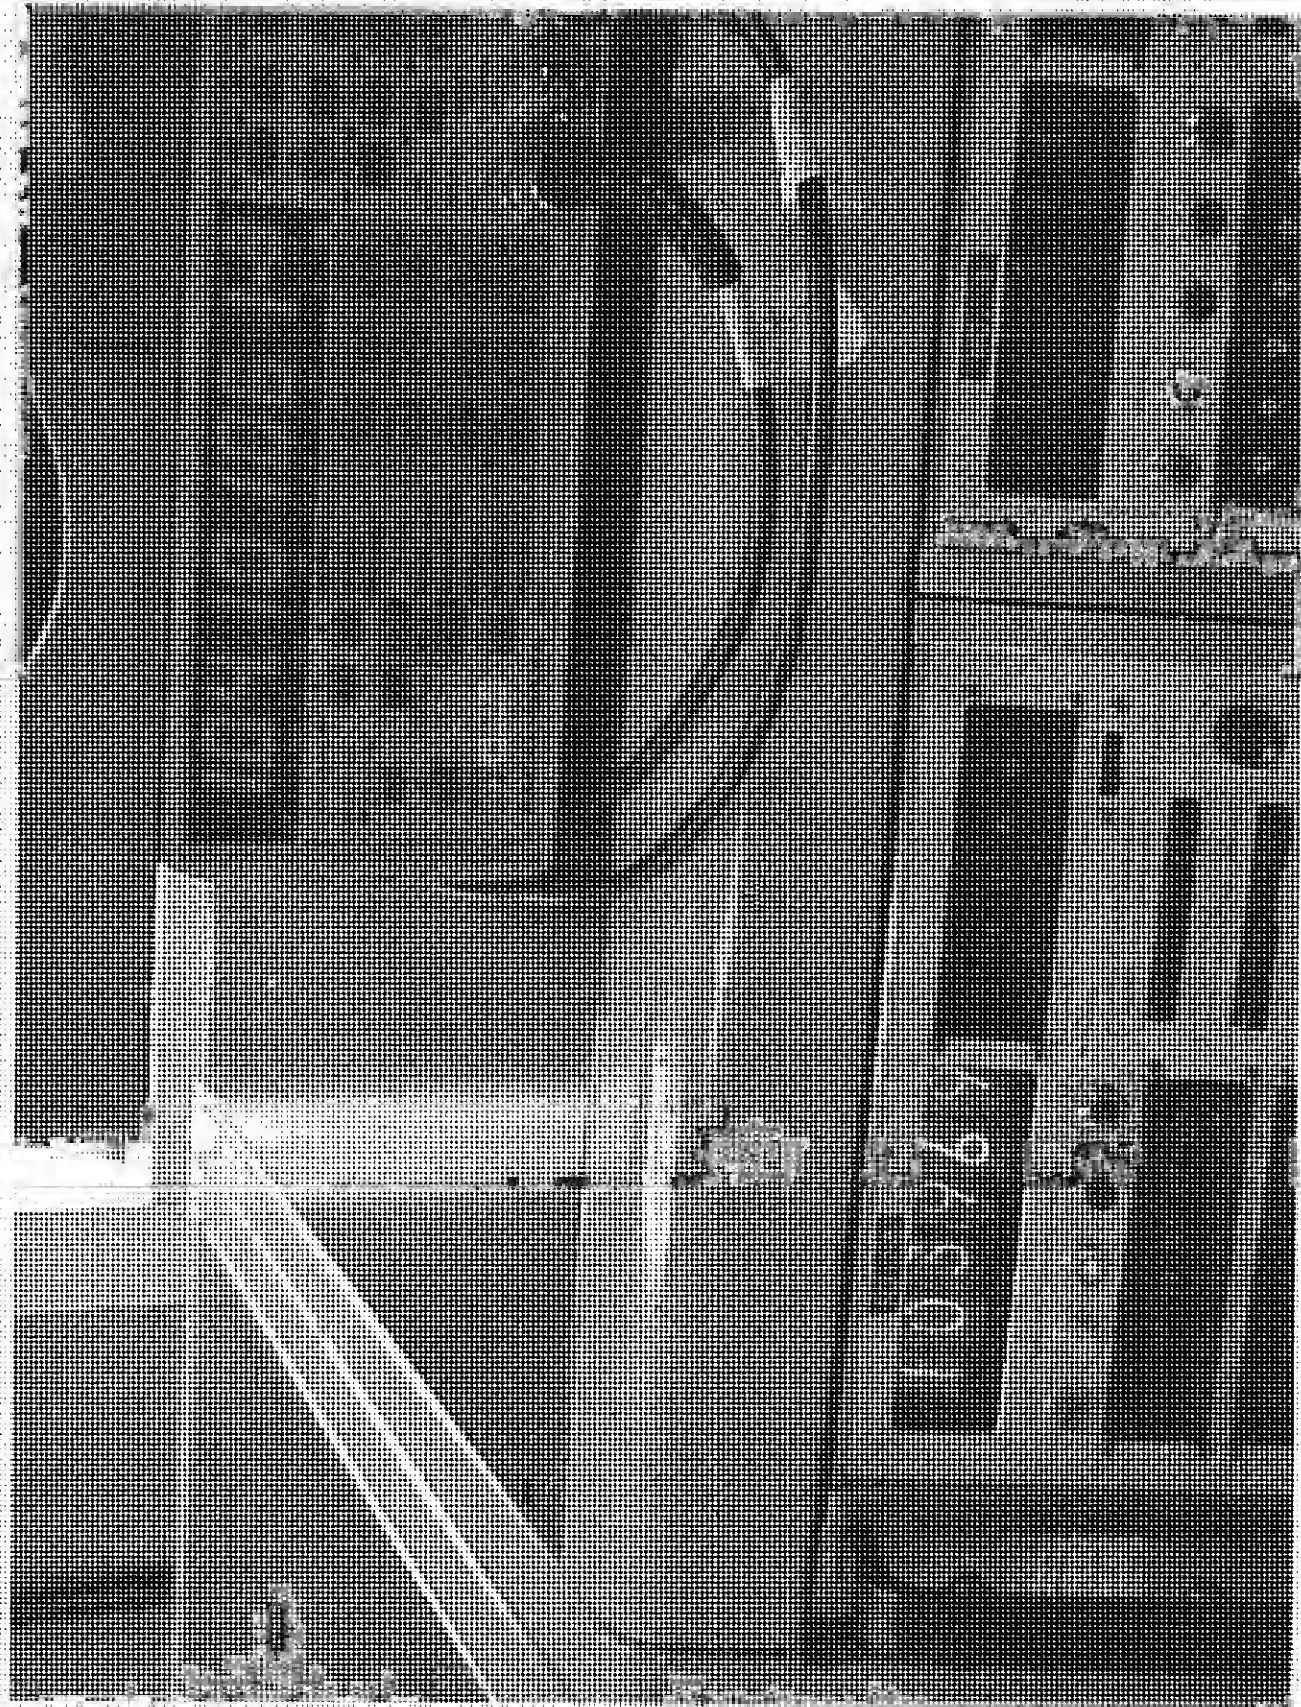
FIGURE 5.38  
SPEED COUNTERS POST TEST

Trap No. 1 = 19.7 mph      Trap No. 2 = 19.6 mph  
Average Impact Speed = 19.7 mph

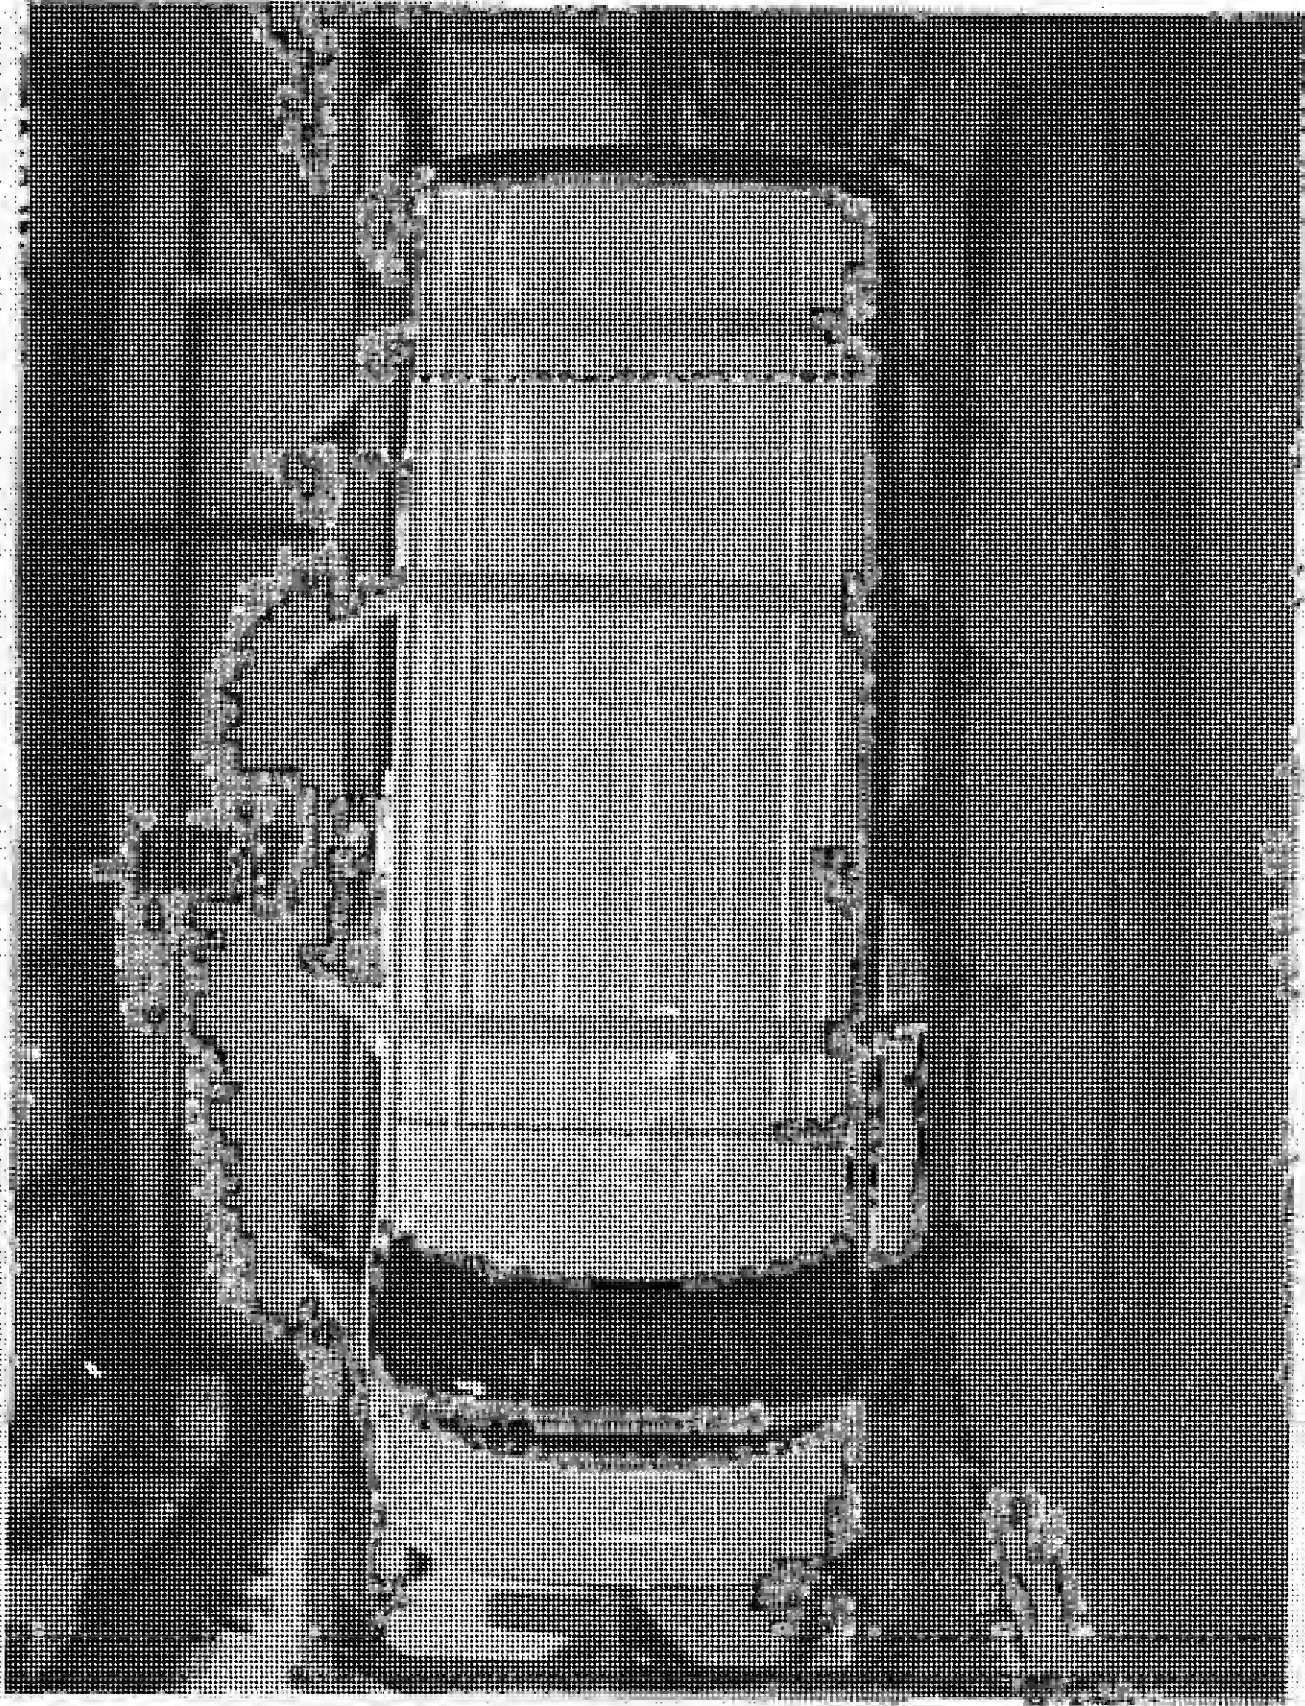
FIGURE 5.40  
VEHICLE IN ROLLOVER FIXTURE AT 90°

Provide Details of Stoddard Solvent Spillage Locations — NONE

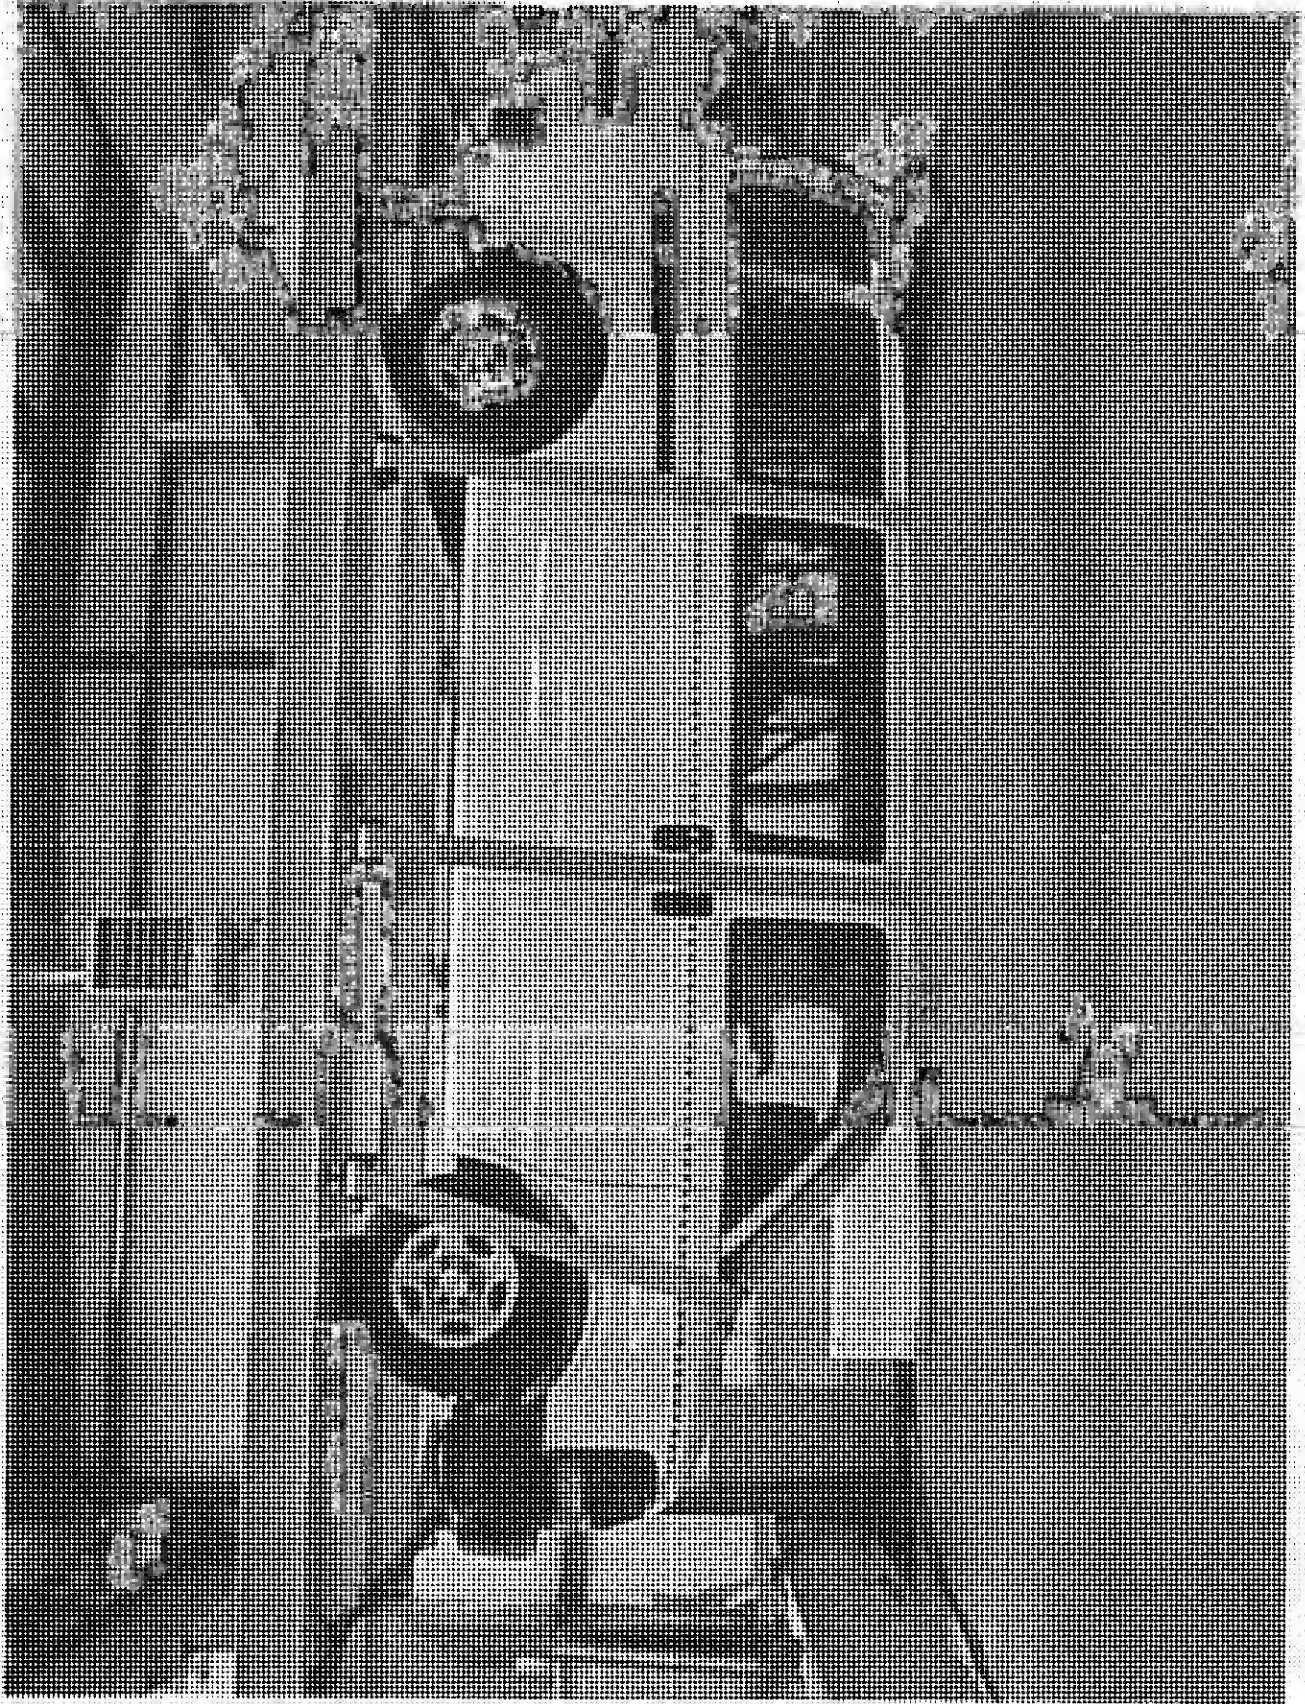
FIGURE 5.41  
VEHICLE IN ROLLOVER FIXTURE AT 180°

Provide Details of Stoddard Solvent Spillage Locations — NONE

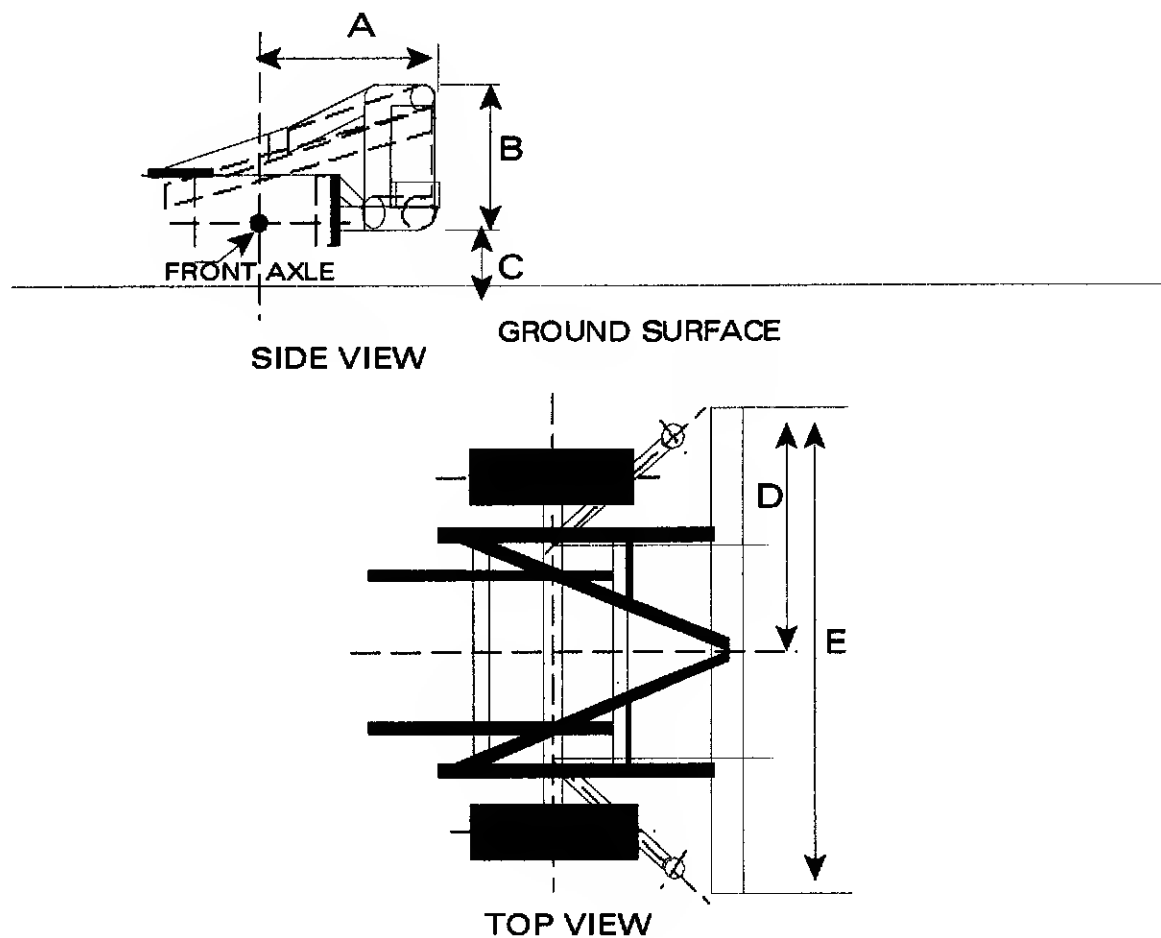
DIMENSIONS FOR GTL 60" x 78" FLAT FACE IMPACT SURFACE

- 1.Face Plate 0.50 in. (19mm) thick cold rolled steel
- 2.All Inner Reinforcements 4.0 x 2.0 x 0.19 in. (102 x 51 x 5mm) Steel Tubing
- 3.Impact Surface above shown without .75 x 48 x 96 in. Plywood Face attached

LETTER	INCHES	MILLIMETERS
A	20.5*	521*
B	60.0	1524
C	5.0	127
D	39.0	991
E	78.0	198

TEST SET-UP OF COMMON CARRIAGE WITH 60" x 78" FLAT FACE IMPACT SURFACE INSTALLED:
